WoodenBoat

The Rebirth of Skuutje WR60

The rescue of an 1840 Dutch herring boat

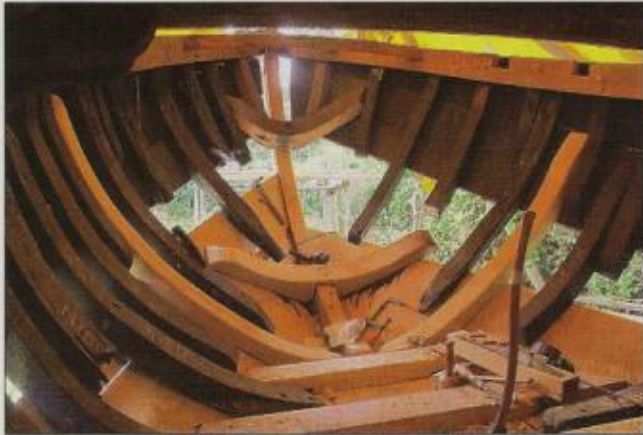
To begin the reconstruction, first the hull was braced to restore its original shape and then its floor timbers and frames, shaped from compass timbers, were replaced one by one. Planking, which proceeded from the bottom up as the timbers were replaced, helped retain the hull's shape throughout the project.

Then the deteriorated frames needed to be replaced. In the original construction, each futtock was hewn from naturally curved wood, which is stronger for the purpose than straight wood sawn to shape. Since most sawmills in modern times deal only with straight wood, curved wood is hard to come by. However, at the time of the restoration, a large stand of oak trees was being cut in Germany in preparation for a mining operation, making a large amount of “compass timber” available for sale. A large trailer was necessary to transport all the large tree trunks and branches to the restoration site—12 cubic meters in all (424 cu ft), eventually whittled down to 80 futtocks, with a final combined volume of 3 cubic meters (106 cu ft). The leftover wood is slowly ending up in the fireplace.

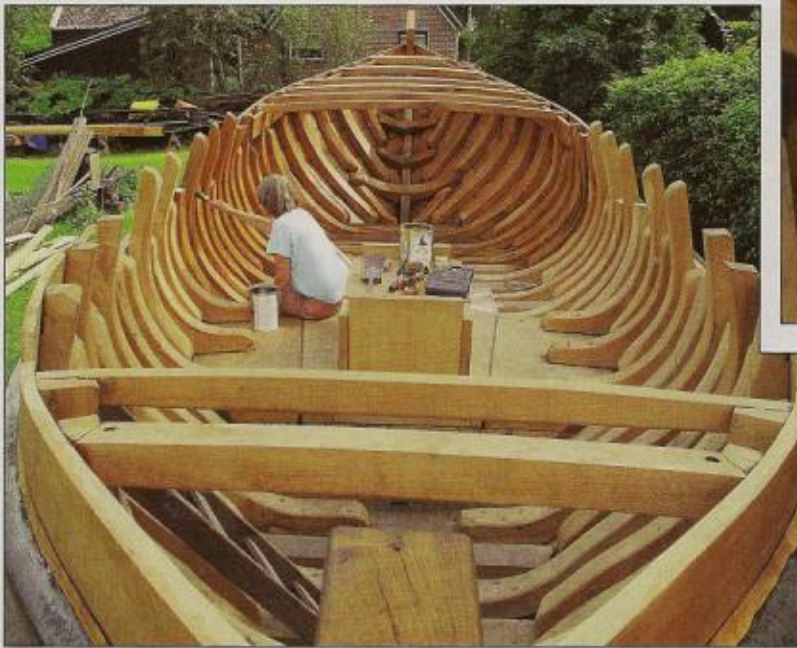
Left—Once the 80 futtocks were replaced, the interior was oiled with a traditional combination of linseed oil and resin called *harpuis*. *Above*—Natural crooks were used to make very heavy hanging knees in way of the mast partners. These obviate the need for shrouds, leaving the skuitje’s gunwales clear for handling fishing gear. The box-like structure is part of the livewell, used to keep the catch fresh.

All Dutch fishing vessels typically had forestays but avoided the use of mast shrouds. The *skuutje* is no exception. Without shrouds in the way along the sheer, the task of setting and retrieving fishing gear was much easier. The mast and maststep, along with the futtocks and knees in way of the mast partners, are of extra-strong construction in order to withstand the increased stress on the hull caused by the lack of shrouds.

Historically, ships such as these would be painted with *harpuis*, a boiled mixture of linseed oil and resin. Harpuijs, the predecessor of yacht varnish, provides great protection for wood and is easy to maintain, but it stays sticky. For this reason, it is applied only on the planking and frames on the inside of the boat. The exterior was coated with multiple applications of tung oil, which has proven to be of great value for the wooden components aboard the steel-hulled clipper reconstruction STAD AMSTERDAM, launched in 2000. One traditional coating used often for the *skuutje* is Stockholm tar. All wood-to-wood joints were coated with four layers of newspaper soaked in tar, a method that historically has proven to prevent rot. Decades-old, but still-readable, tar-soaked newspapers were discovered in the original joints.
